CENTRAL INTELLIGENCE AGENCY

KALOCSA: Hungarian Barracks (POKTO Road)
(not to scale)

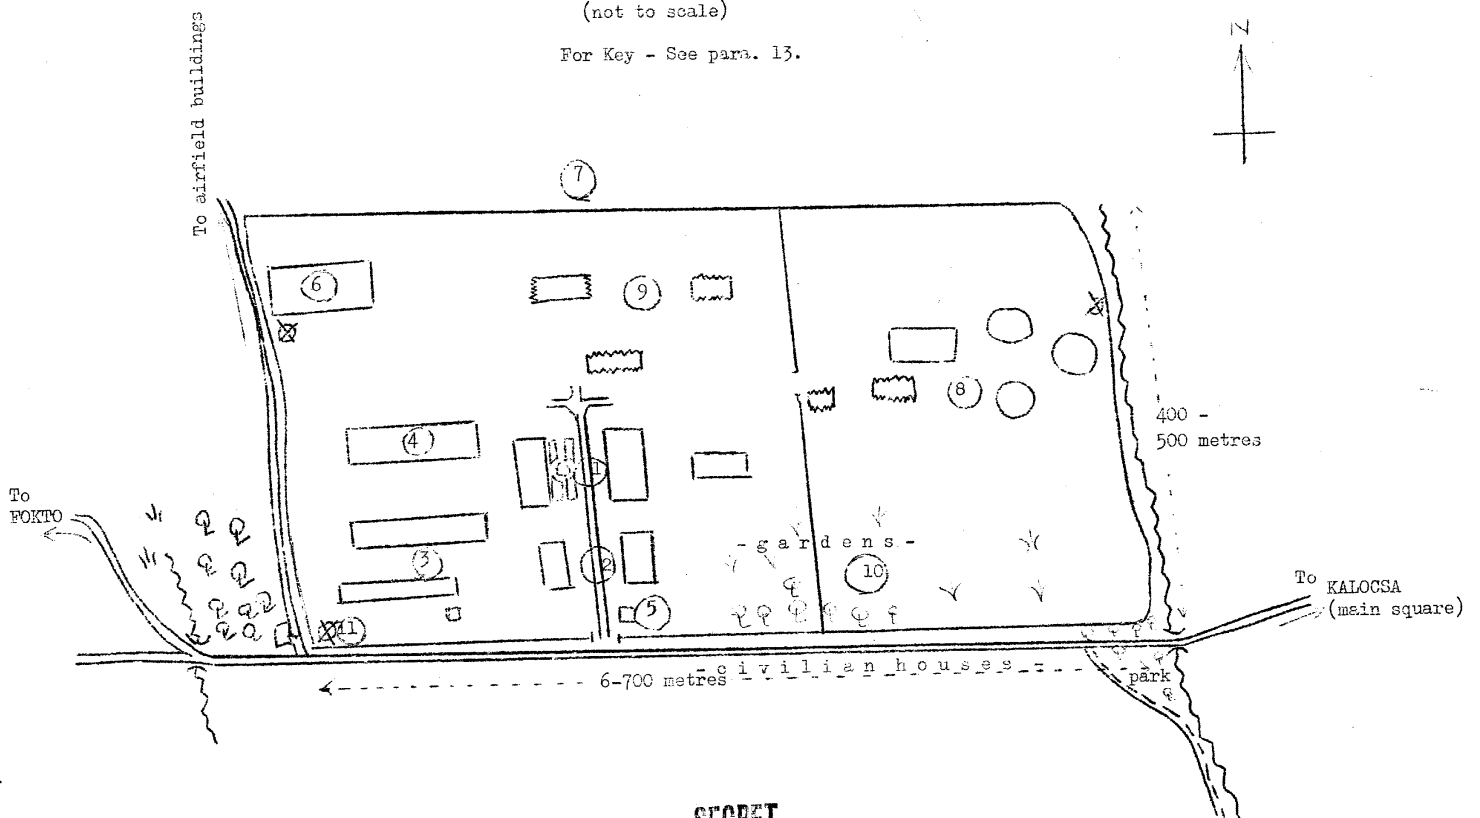
SKETCH A

1. The barracks on the Fokto road are situated immediately on the outskirts of the town, on the north side of the road leading to Fokto. The barracks (see sketch A) cover an area of about 500 x 700 m. and are surrounded by a wire fence. The main entrance to the barracks is on the Fokto road.

7. One of the buildings in the barrack area is most certainly a headquarters (see sketch A no.1). The entrance to this building is guarded by a sentry with rifle. On the top of the building there is a flag and in front there is a well kept lawn. Mostly officers (who arrived by car) were seen entering the building.

1. Two 3-story buildings opposite each other, approximately 50 x 25/30m. Flag on westernmost building.
2. Two 2-story buildings, somewhat smaller than the buildings at 1.
3. Single-story building, approximately 45-50 x 10 m. Not flat-roofed. Many windows. The building behind it appears similar.
4. Larger single-story building with flat roof.
5. Entrance and guard-house.
6. A very large grey 4-story block which appears to be used as living quarters.
7. Building in progress, concrete mixing machines, excavators (Sztalinetz), sacks of wood, bricks, & other materials. North of the northwest corner, the construction of new airfield buildings has already begun.
8. Buildings under construction; also 3 or more curious circular buildings which are completely new (see sketch B).

9. Buildings under construction (indicated by wavy line).
10. Field. Soldiers with green collar patches seen uprooting trees as though clearing ground for building. Posts being inserted.
11. Watch tower (sentry with green collar patches patrolling area beside garden).

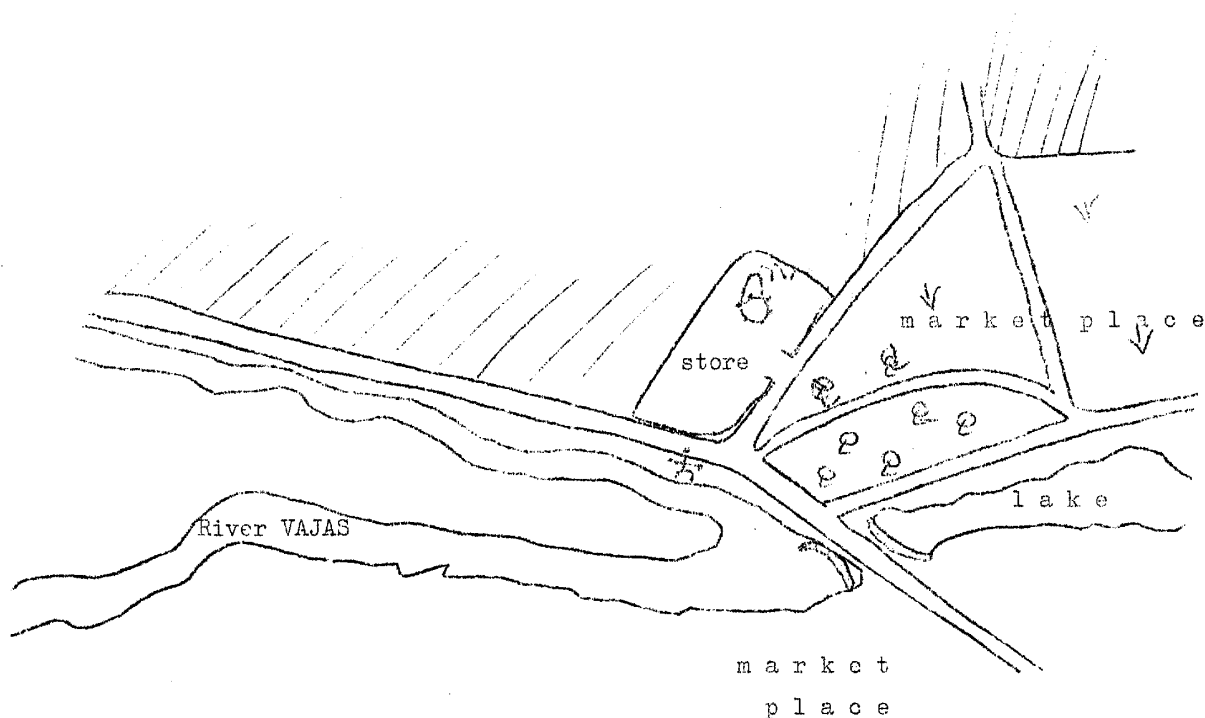
SKETCH C

8. In the southwest part of Kalocsa there is a military mill and in the same area a food store with a bakery (see sketch C). The mill has a chimney about 35 to 40 m. in height. Behind the mill there is a large U-shaped building. The sentry at the above-mentioned store wears a green collar patch. The majority of the workers are civilians and include women. At the time of observation trucks loaded with bread could be seen leaving the store. Motor-transport activity was noticed in the early hours of the morning and late in the afternoon.

KALOCSA: Military Food Store

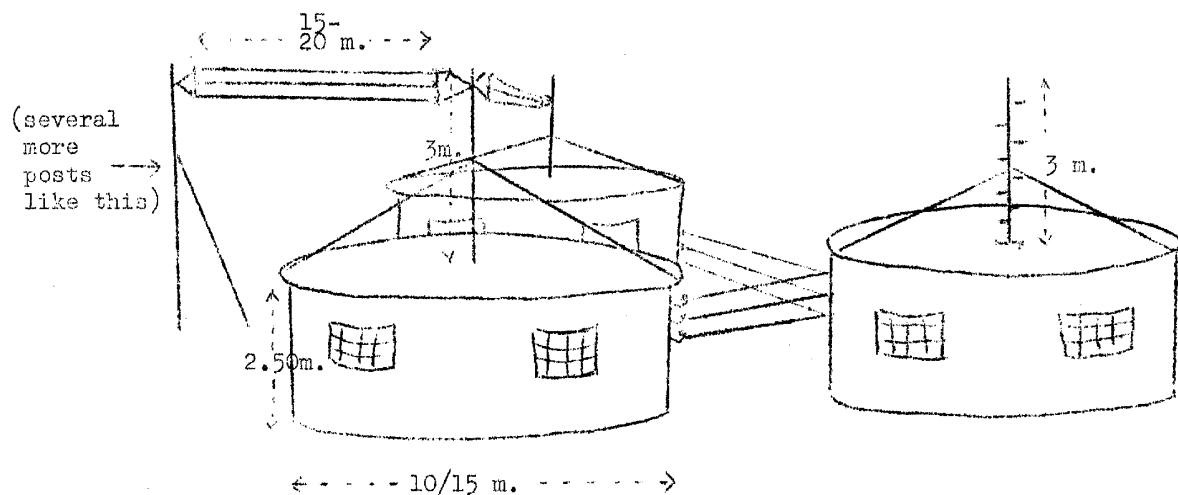
SKETCH B

4. There is a radio station in a fenced-off area in the east part of the barracks (see sketch B). Building activity was in progress around the radio station and bulldozers, cranes, and concrete-mixing machines could be seen. Troops were seen working on the construction; there appeared to be only one or two civilian workers at the site.

Circular buildings and aerials seen at FOKTO Road Barracks,

(Doors on N. side)
